NORTON 961 UNCOVERED

TECH SESSION INTERNATIONAL NORTON
OWNERS CLUB

BY JIM BUSH
“THE BUSHMAN”

2013 NORTON CAFÉ RACER
BOUGHT USED AT 1500MLS, 1 YR OUT OF WARRANTY

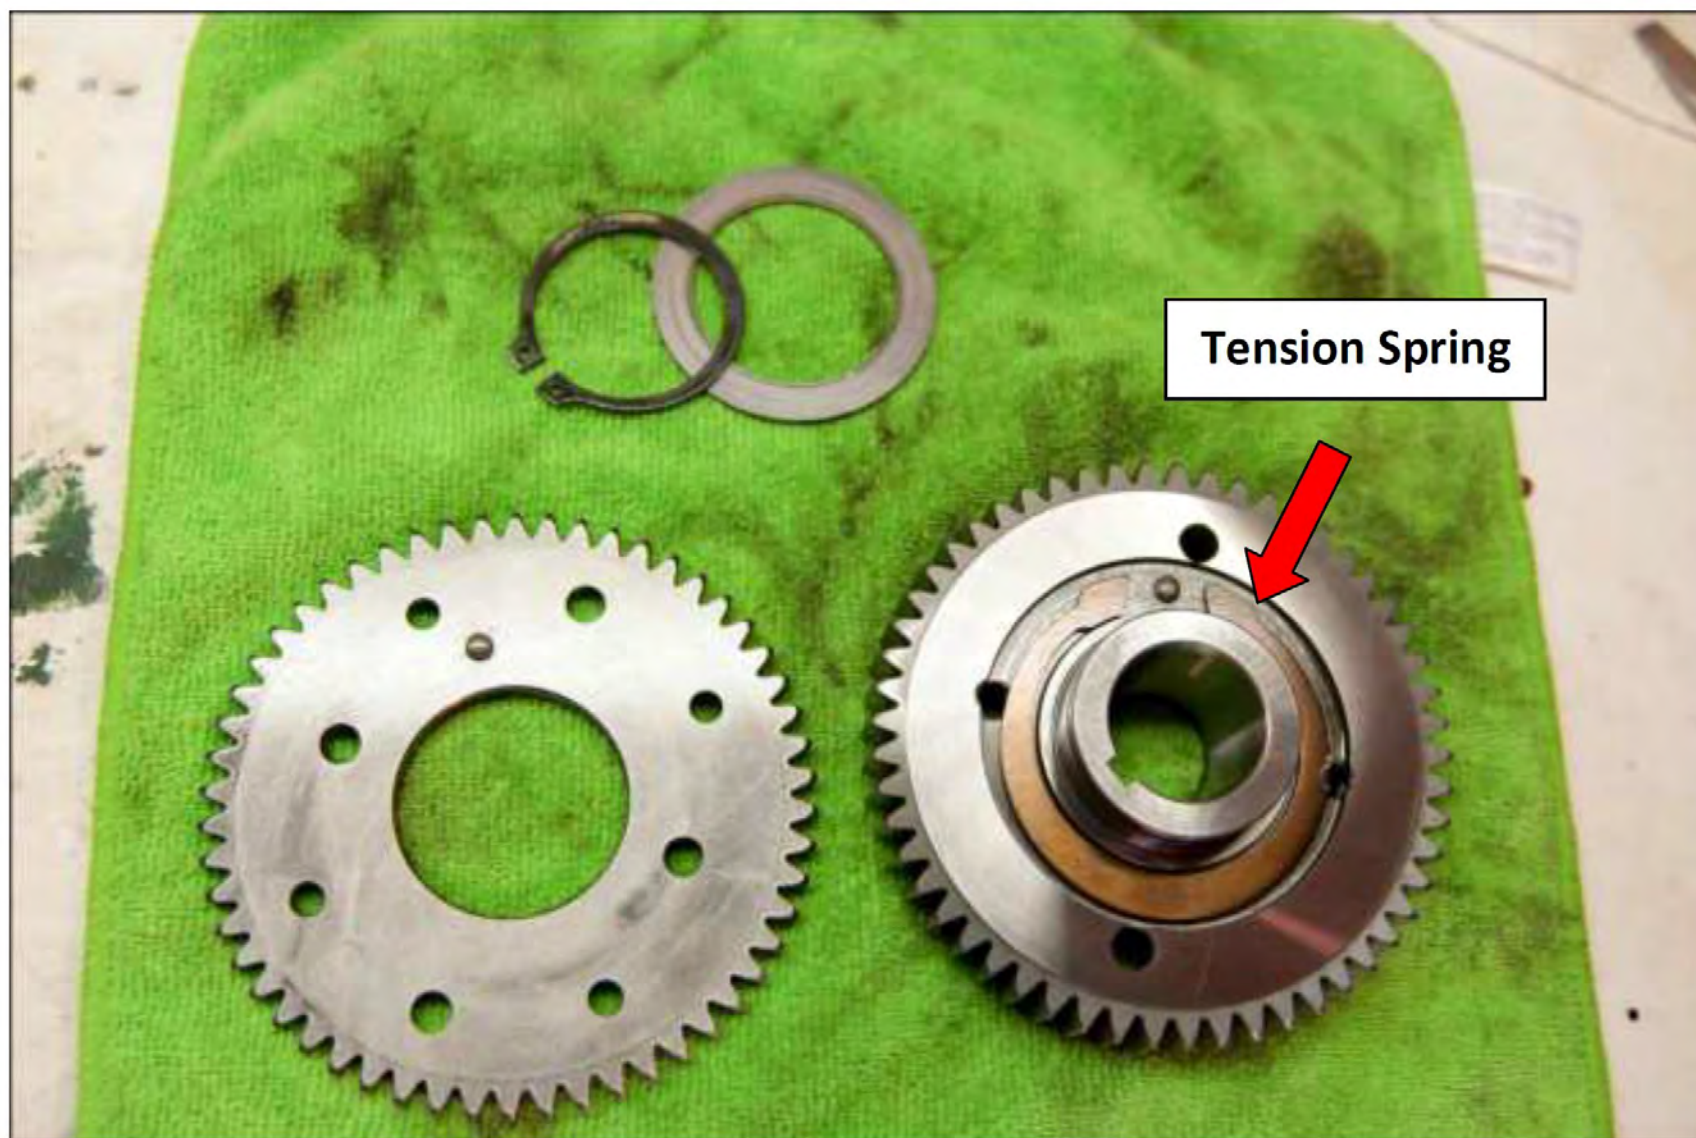
The first fix – NEW TENSION SPRING

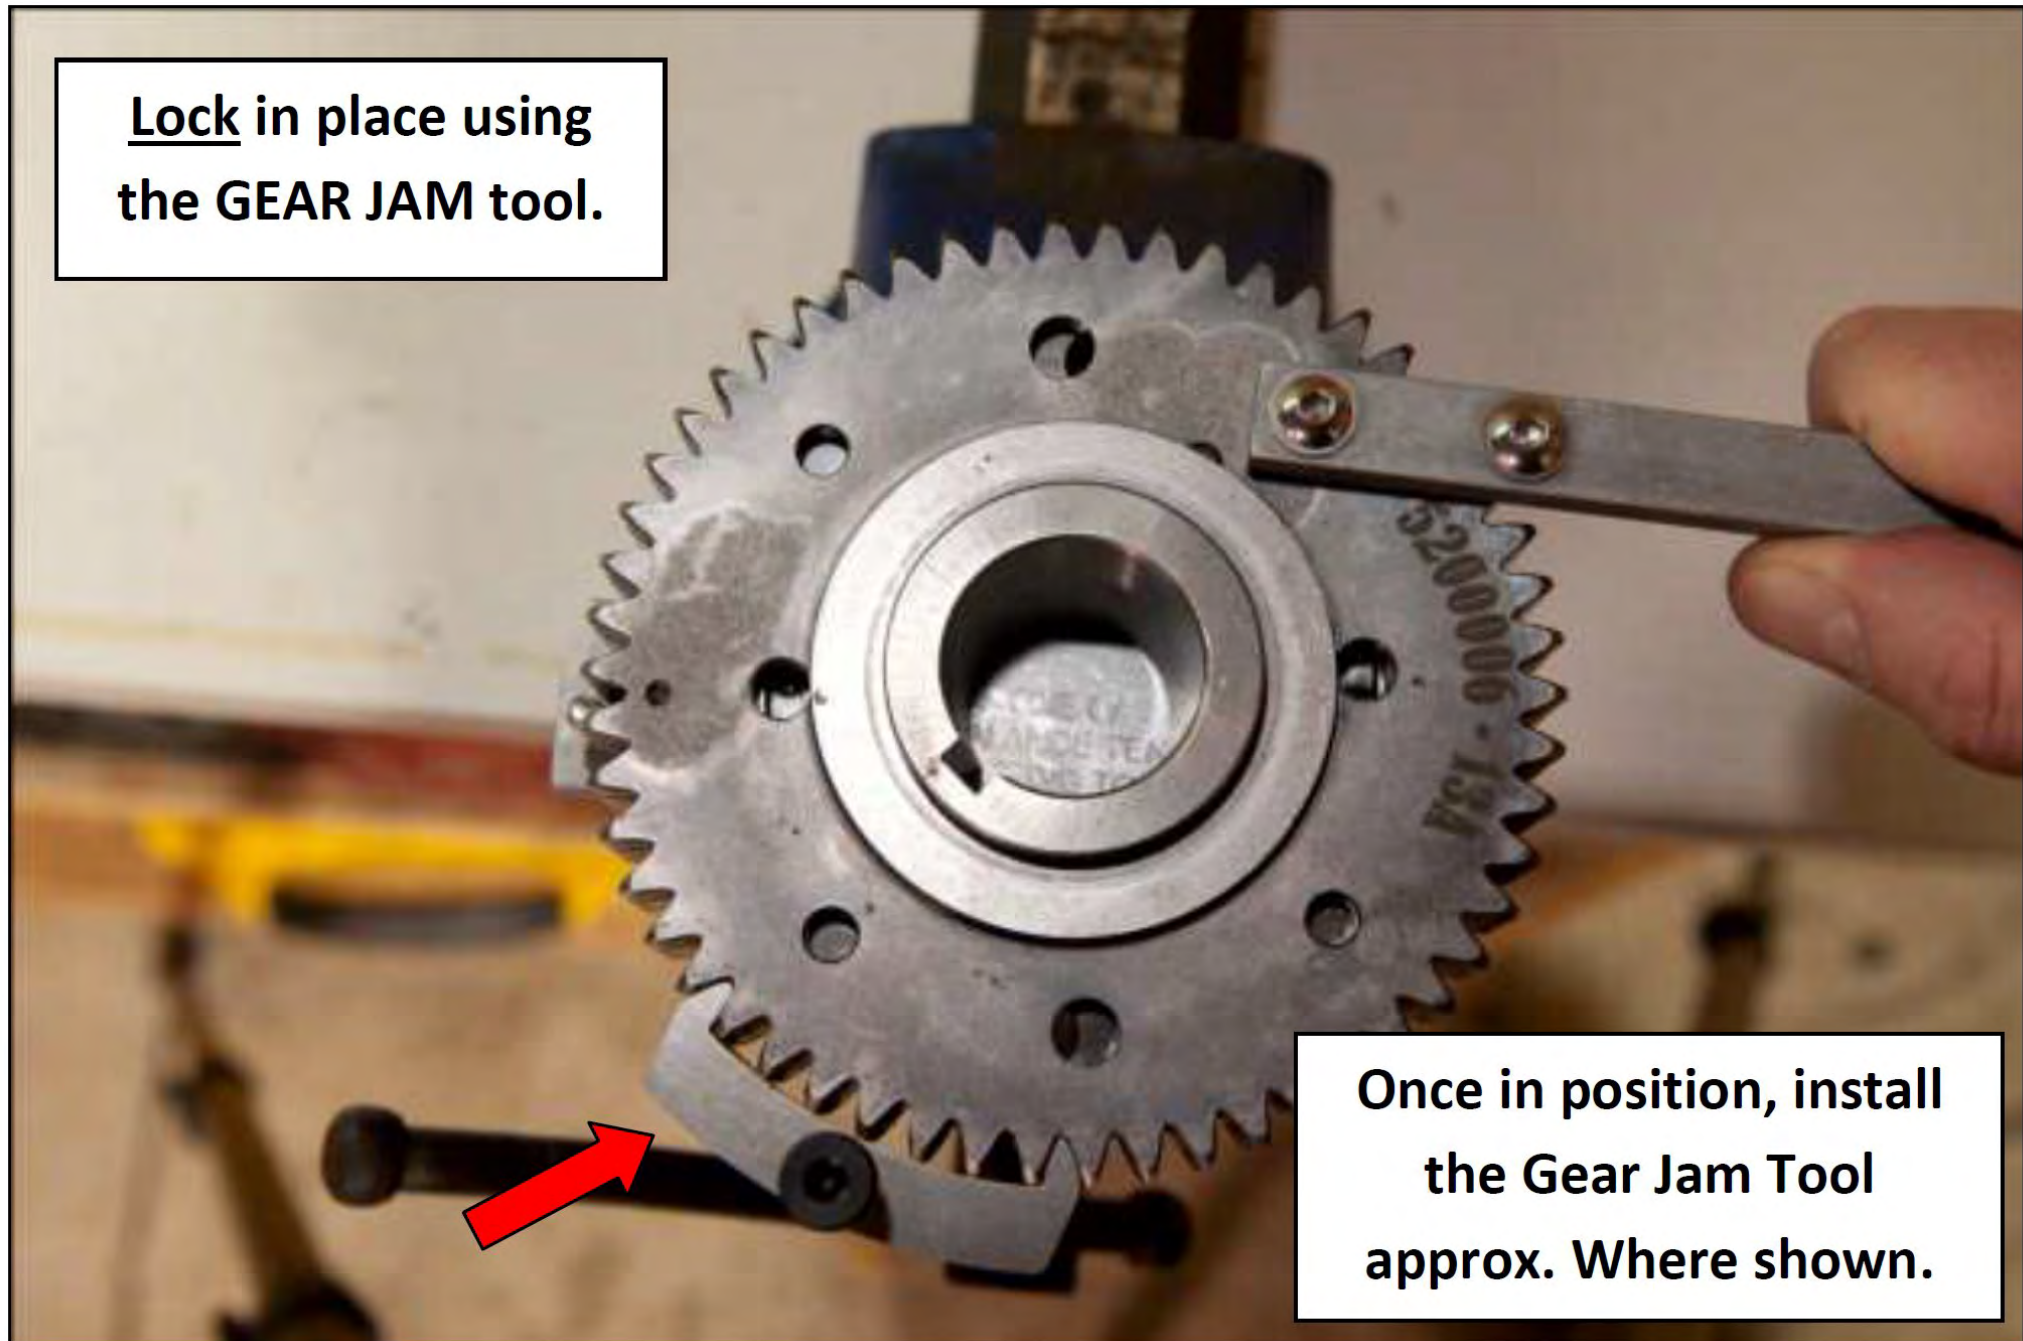
Lock in place using
the GEAR JAM tool.

Once in position, install
the Gear Jam Tool
approx. Where shown.

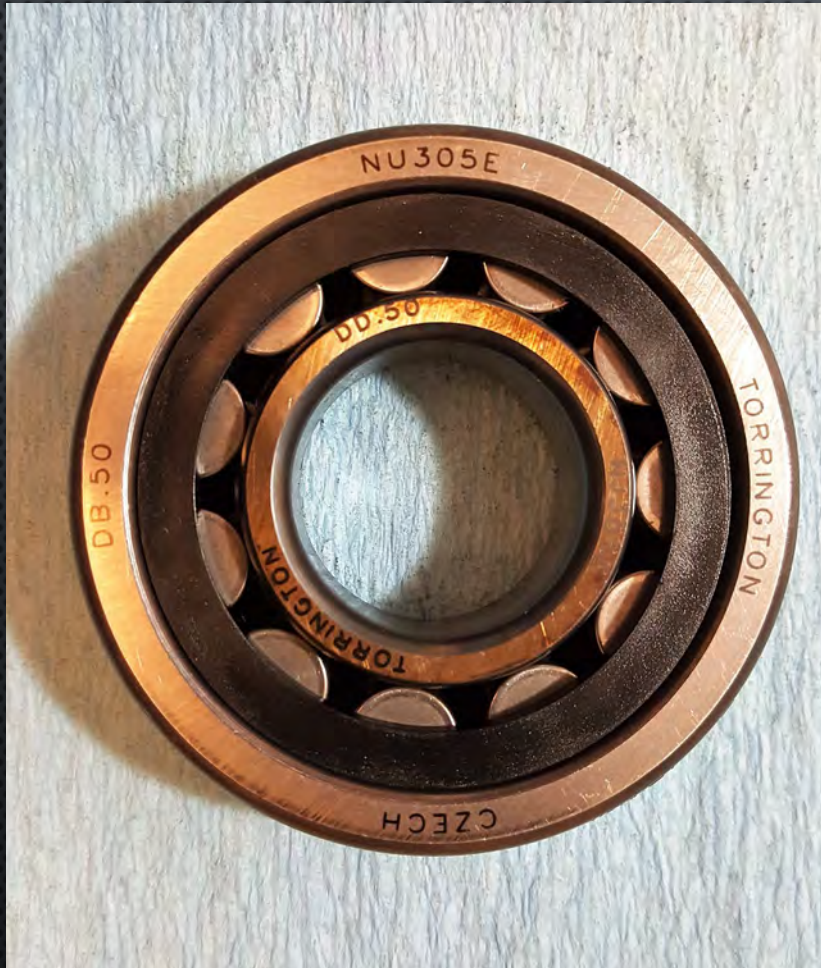
THE BALANCE SHAFT BEARING NJ305E

Norton's famous "super blend" is NJ306E

This is CZECH made Torrington with plastic cage that had failed... 1500mls !!

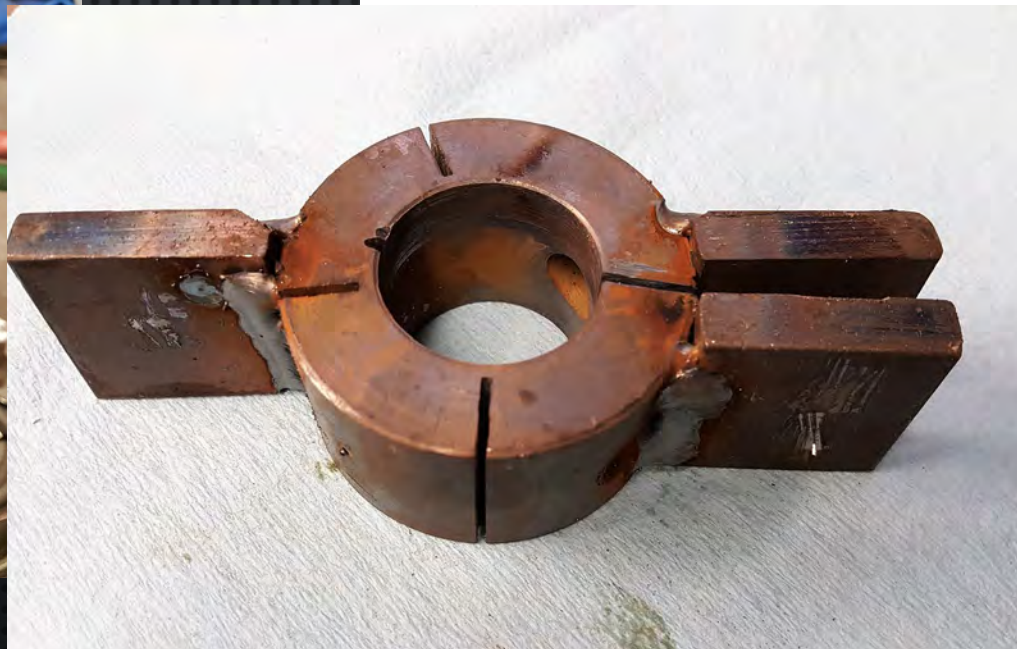
Fig

HOT DISMOUNTING

Special induction heaters have been developed to dismount the inner ring of cylindrical roller bearing having no flanges or only one flange.

They heat the inner ring rapidly without heating the shaft to any degree, so that the expanded ring can easily be removed.

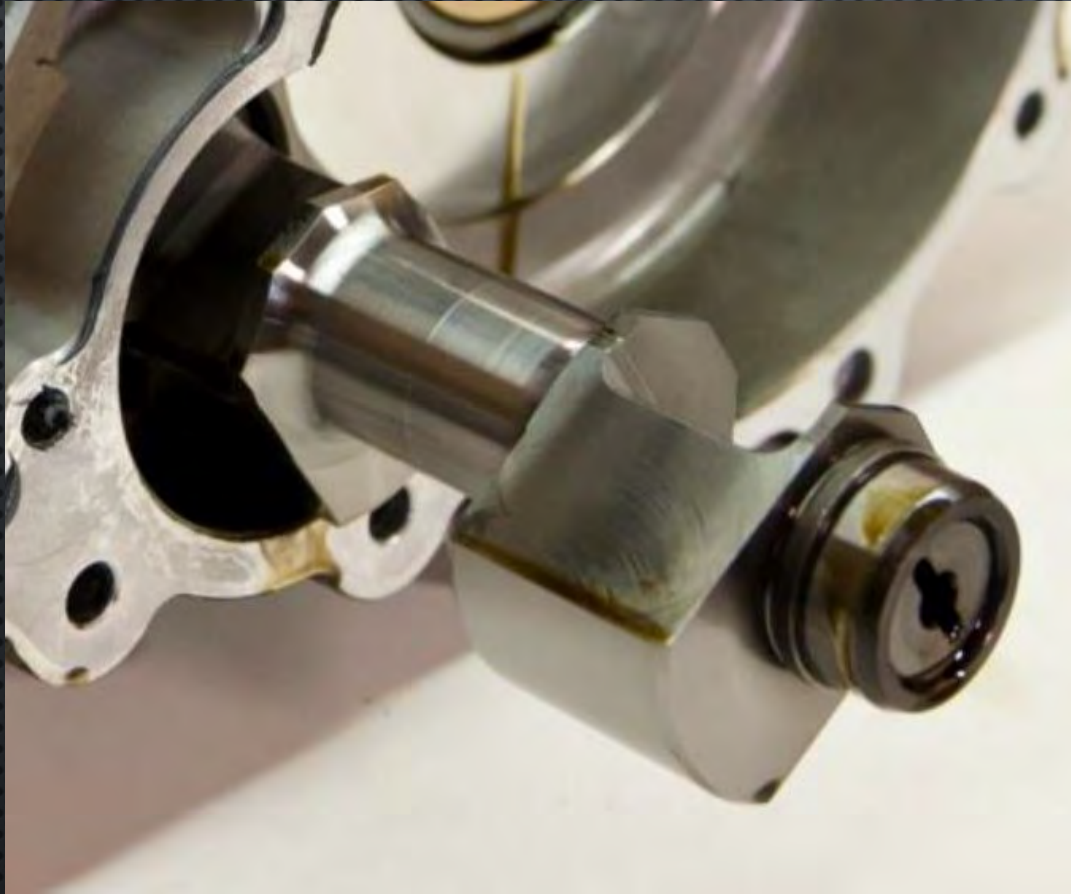
This is the early CNC machined shaft,
replaced by the forged version that I had.

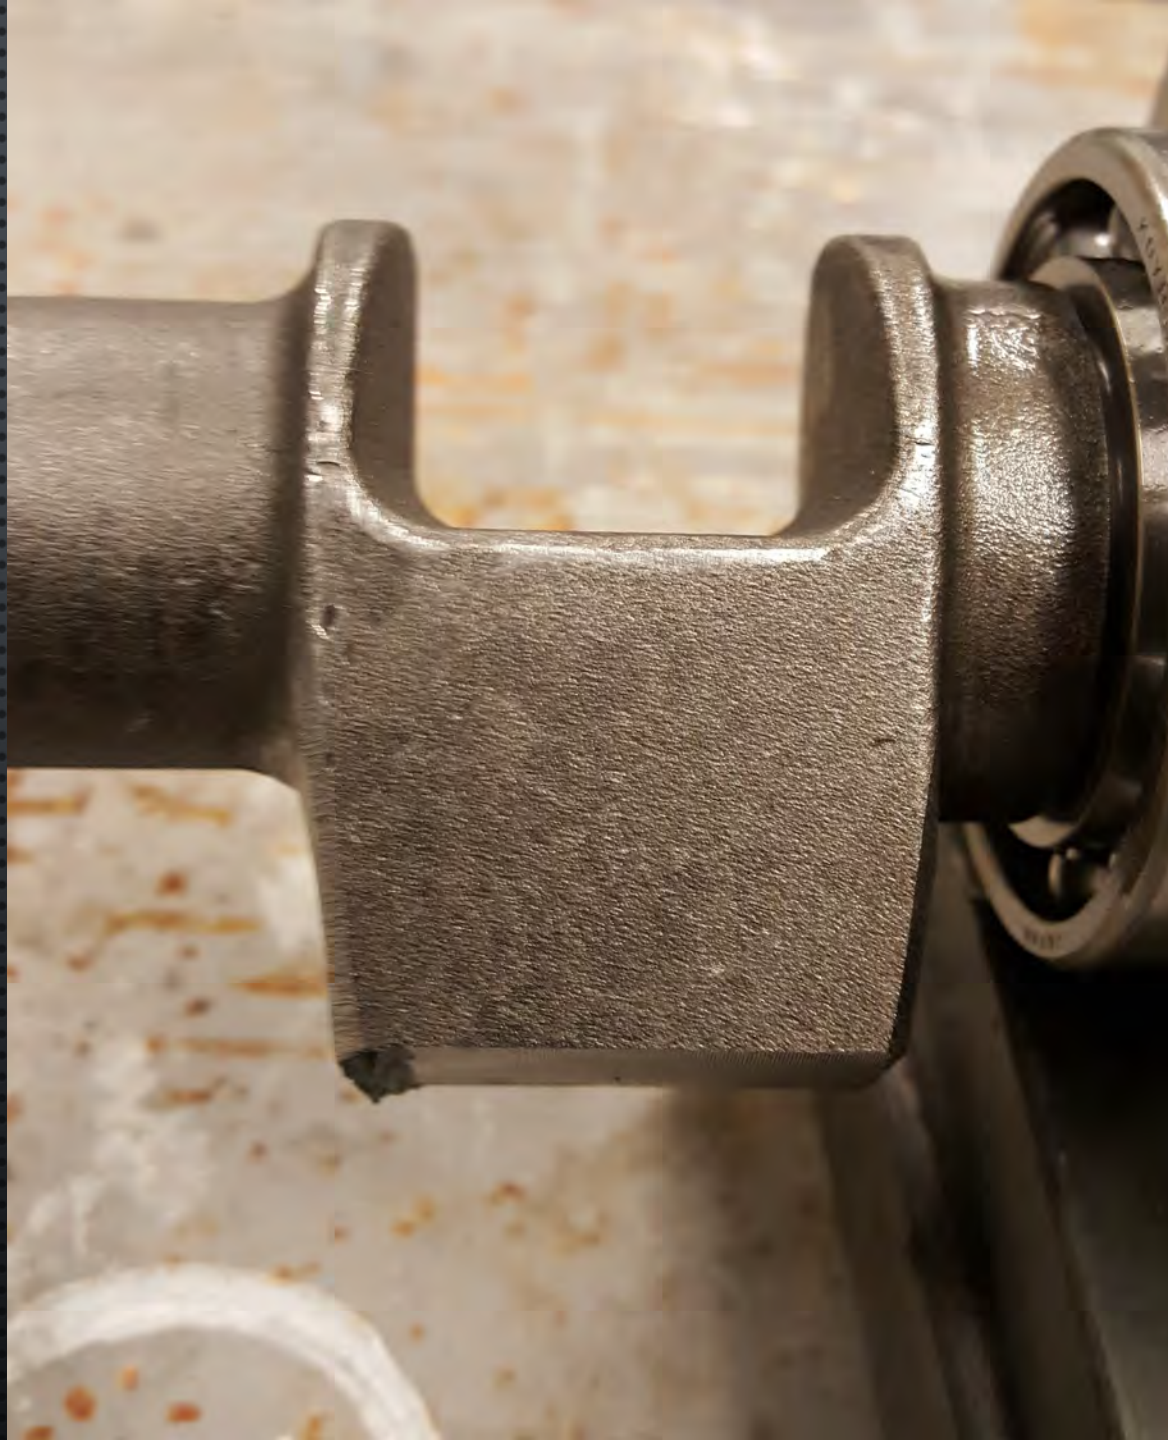
I HAD TO
REMOVE 3OZ
OF MATERIAL
OFF ONE OF
THE BOB
WEIGHTS

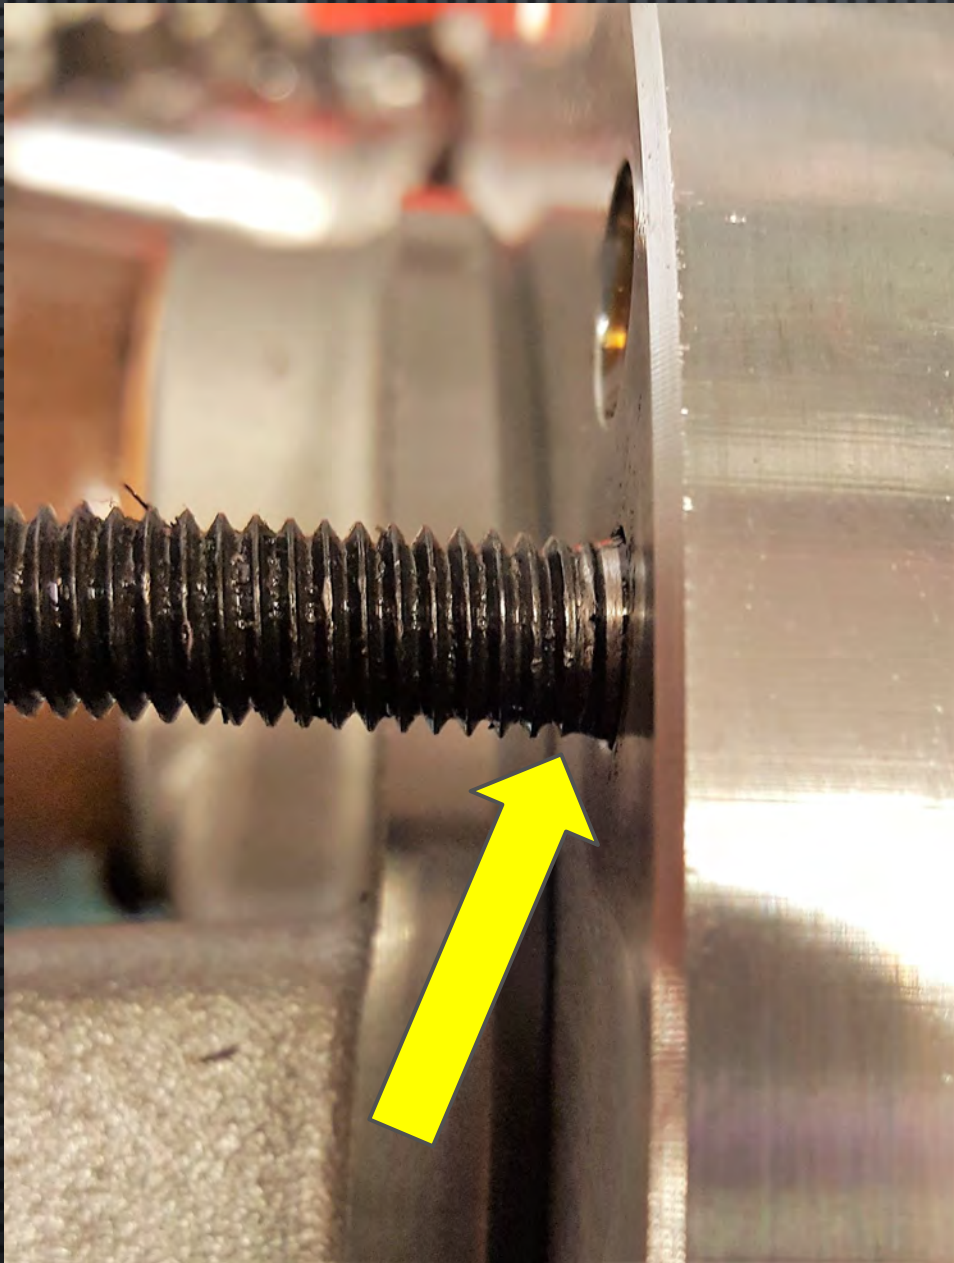
THE SHOULDER OF THE STUD IS BOTTOMING OUT
ON THE THREADS IN THE CRANK CASE.

THE MOUNTING PLATE IS LOOSE !

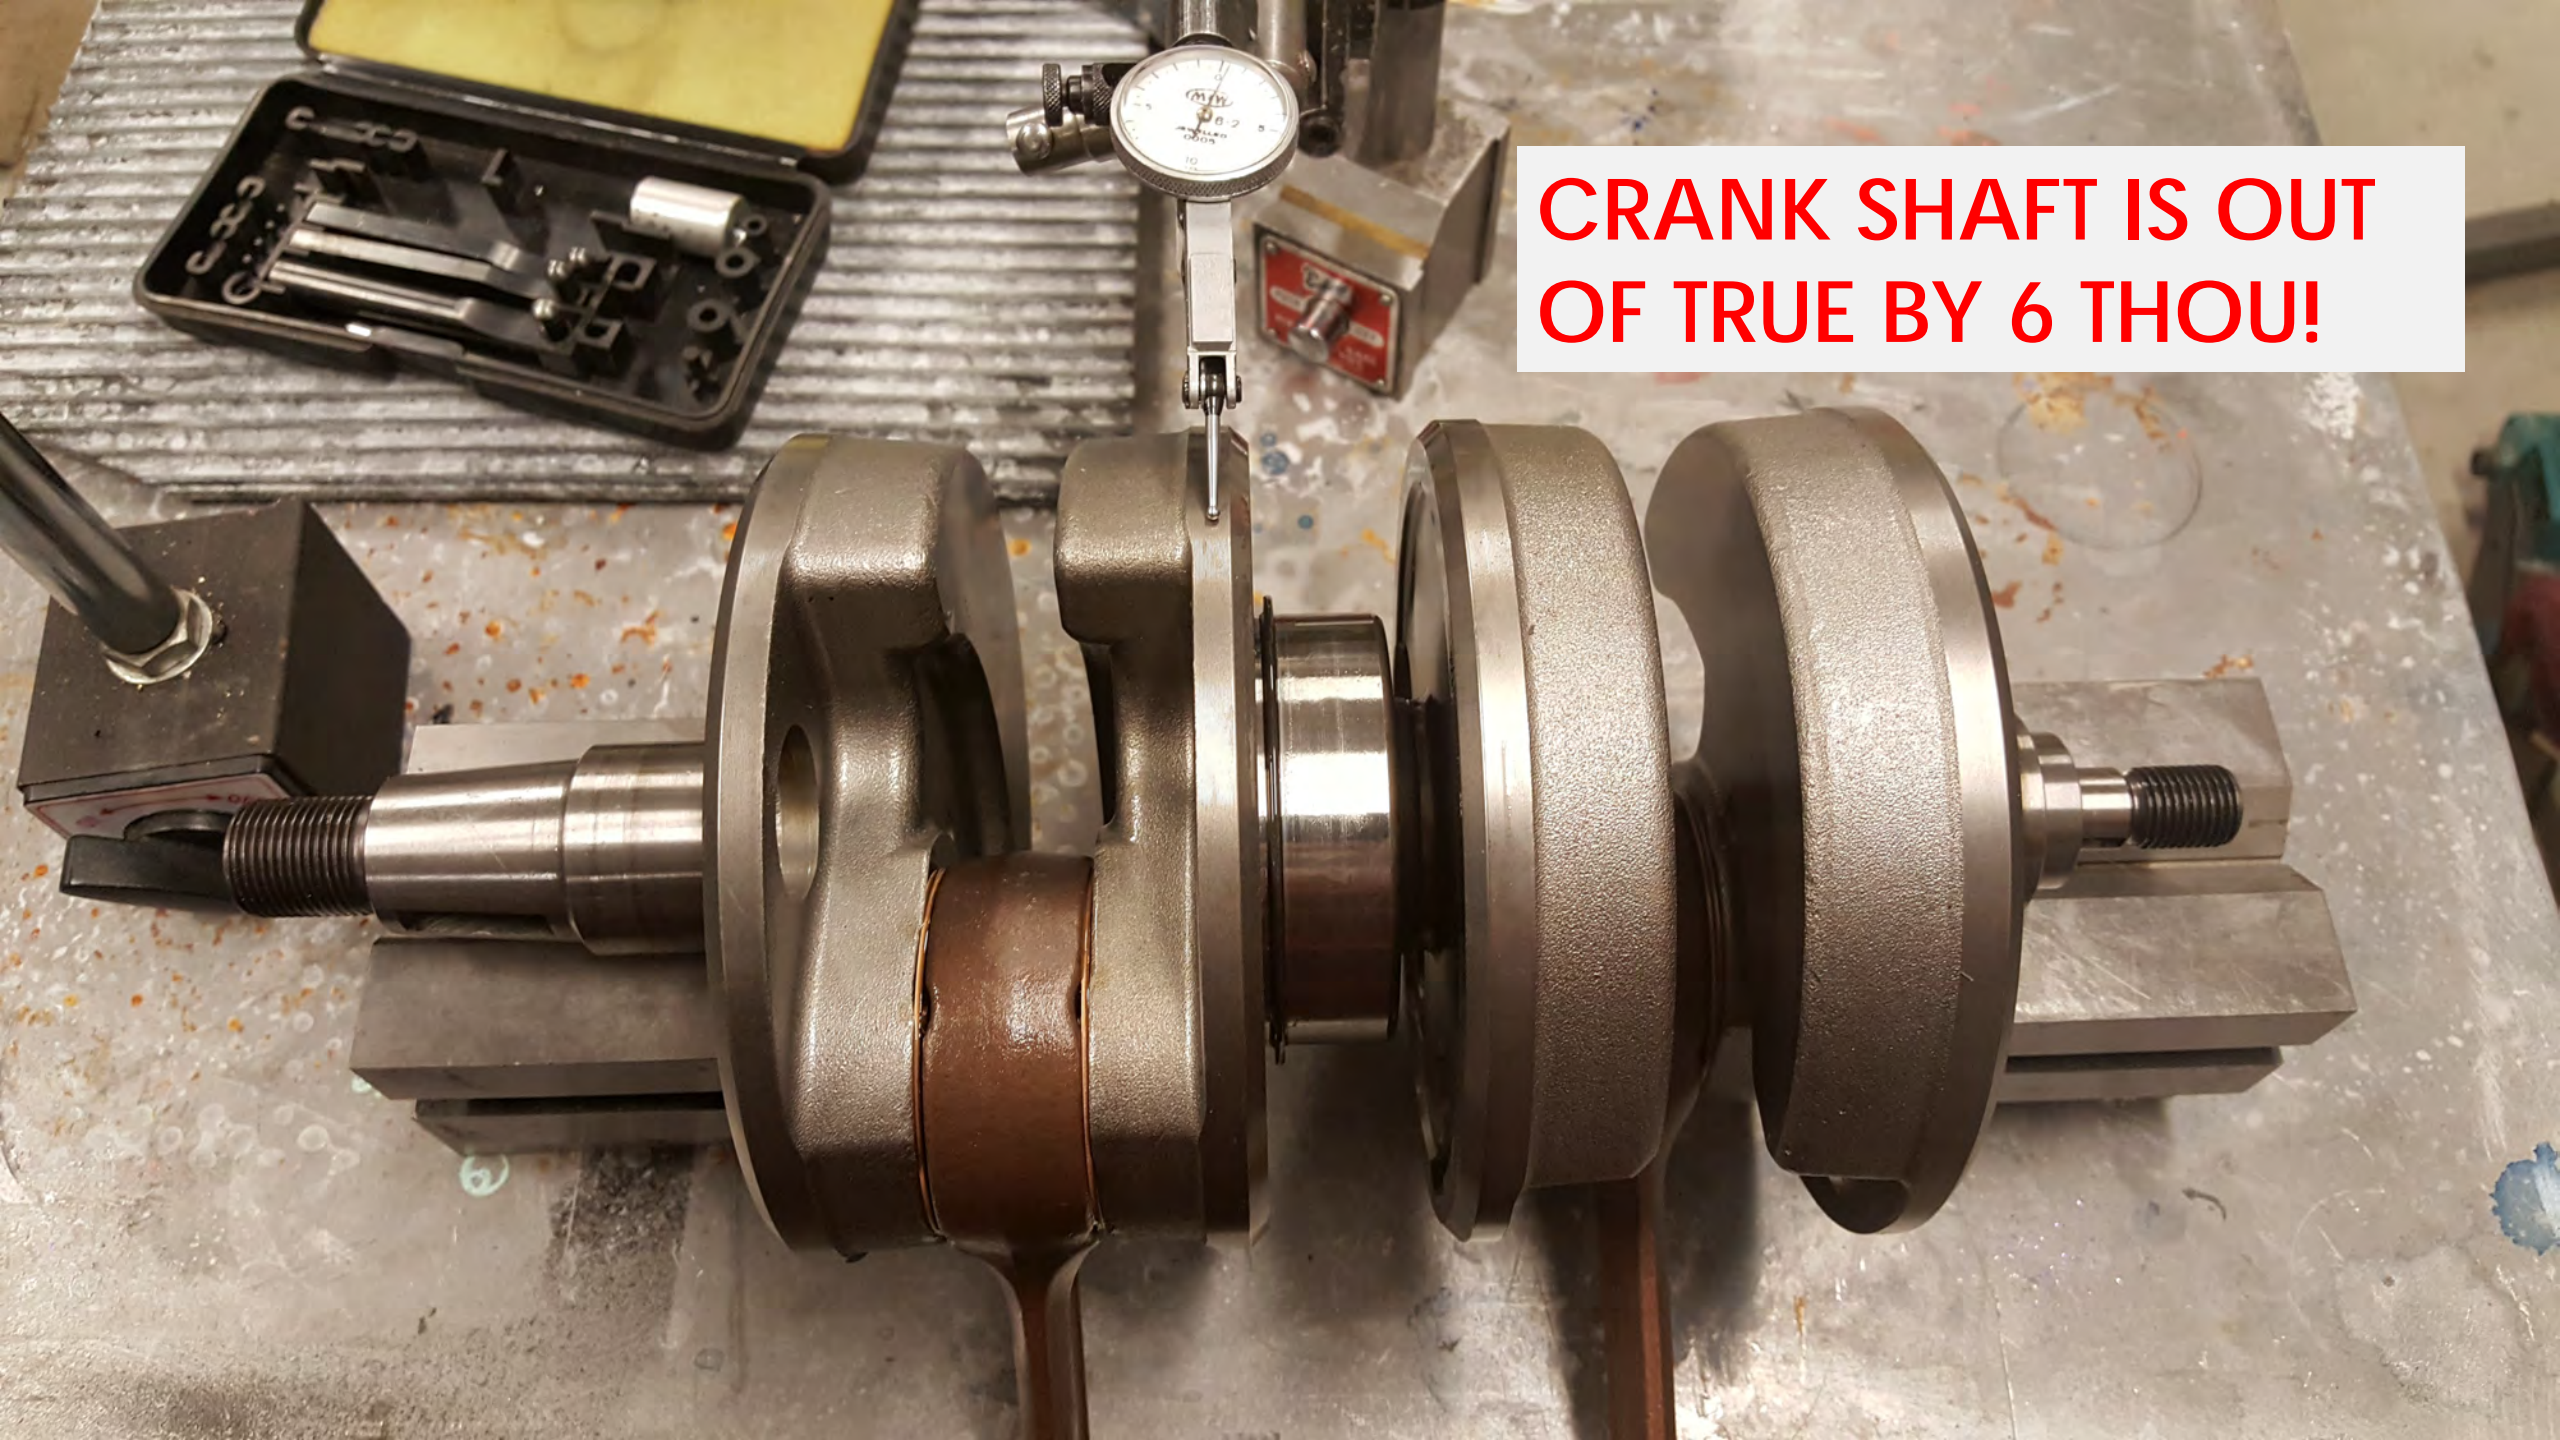
**CRANK SHAFT IS OUT
OF TRUE BY 6 THOU!**

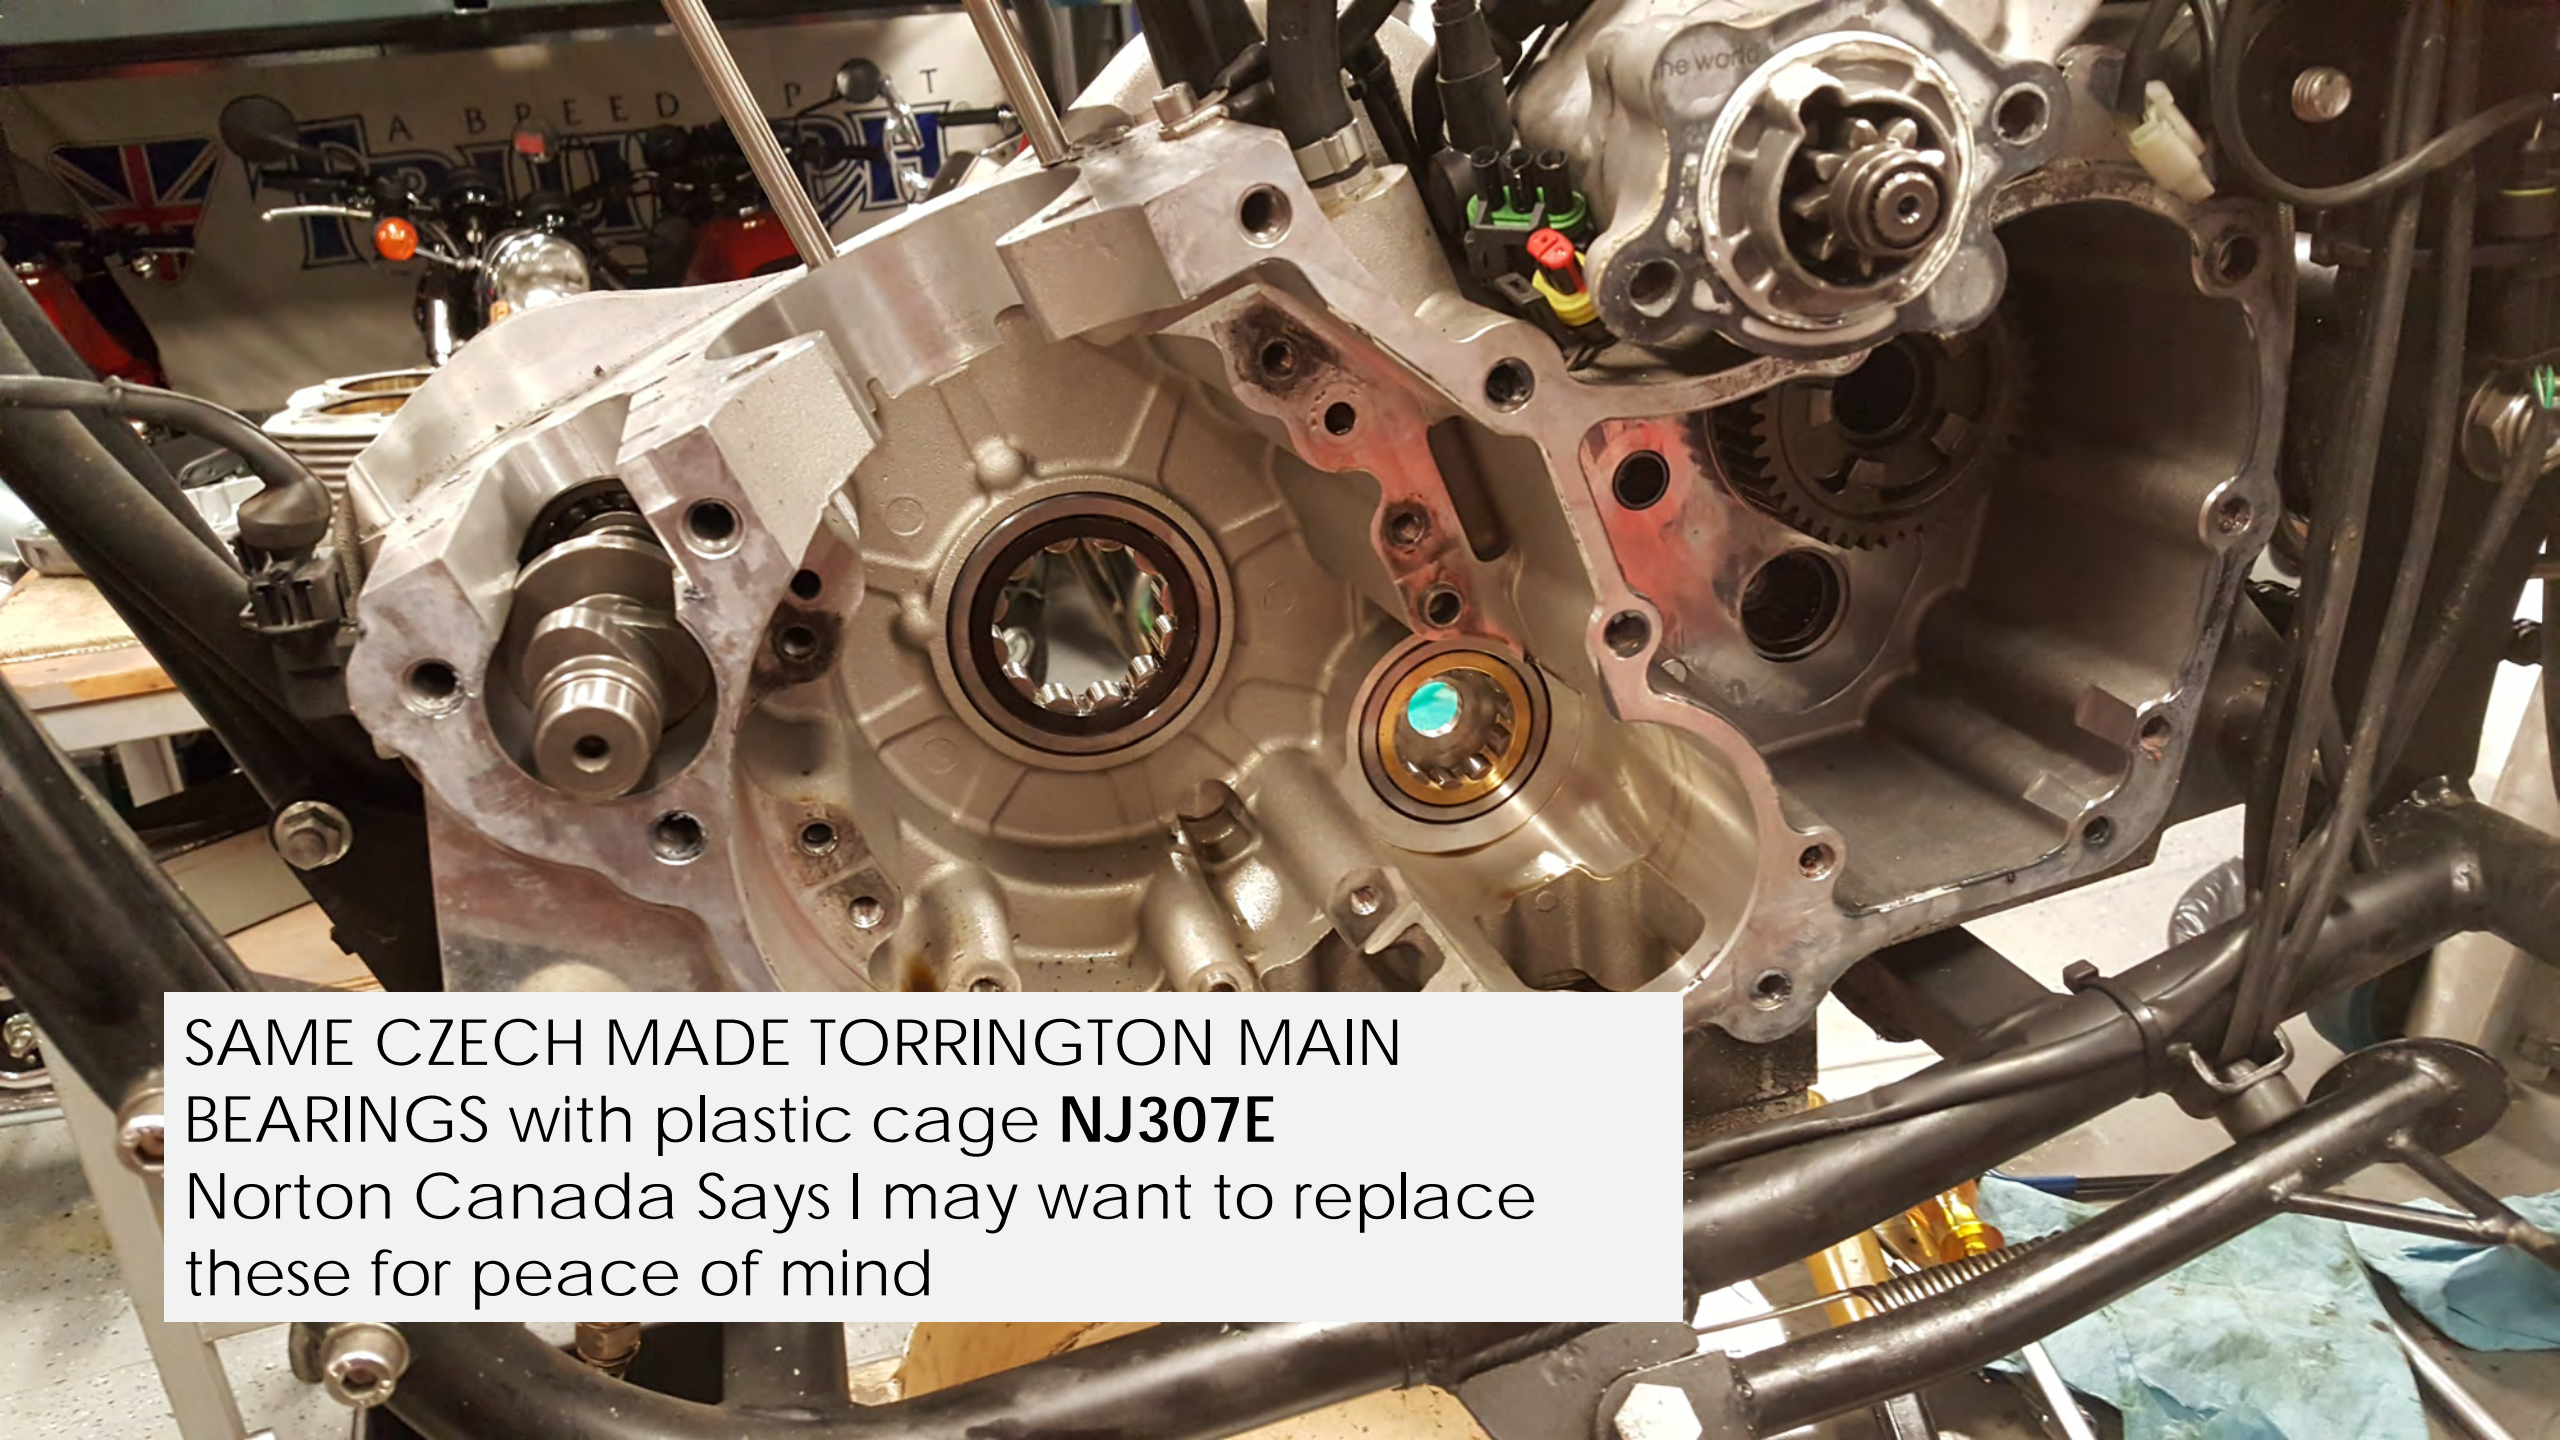
SAME CZECH MADE TORRINGTON MAIN
BEARINGS with plastic cage **NJ307E**
Norton Canada Says I may want to replace
these for peace of mind

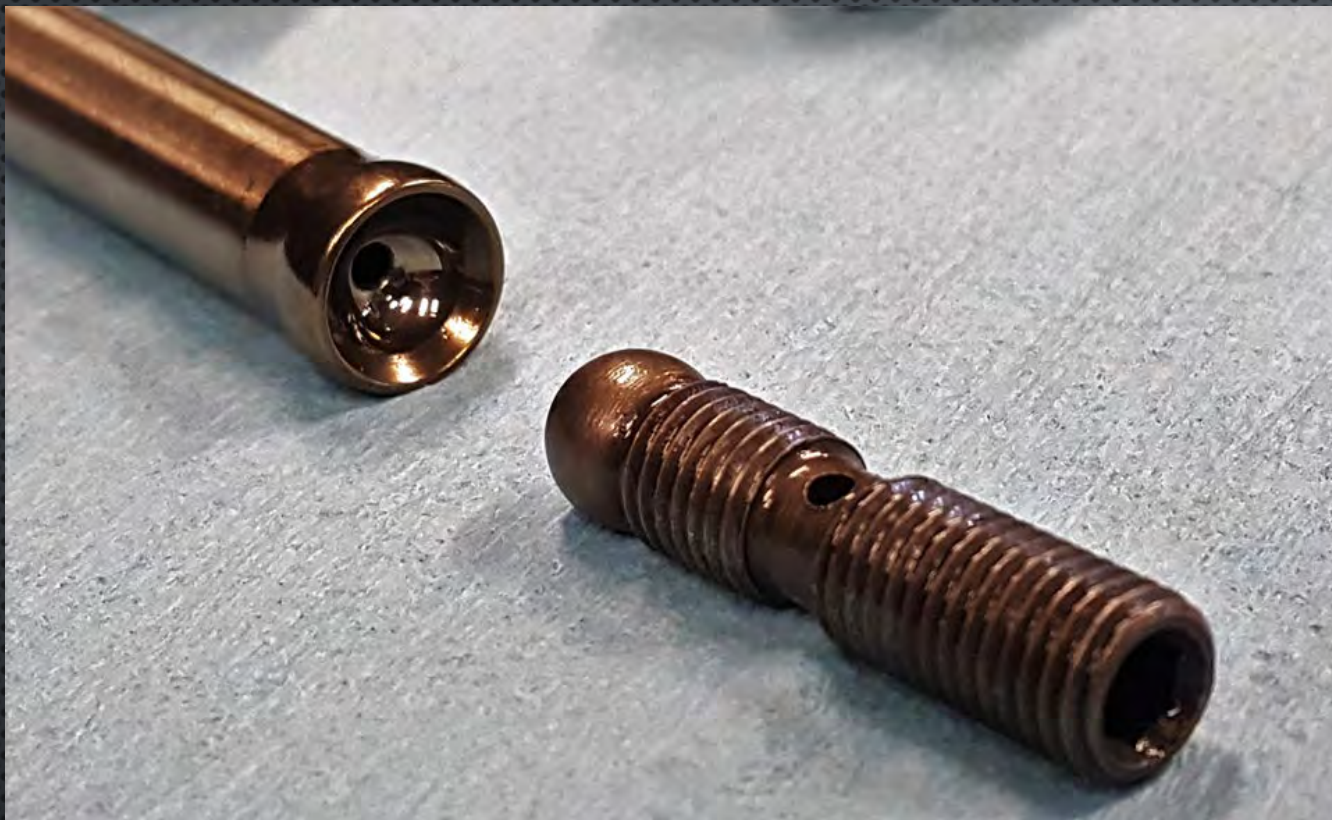
This undercut allows
oil to enter and go
into the push rod
